# **2013 Assessment of the Biology, Habitat and Chemistry of Select Streams and Watersheds of Chesterfield County, Virginia**

**Chesterfield County  
Department of Environmental Engineering  
Water Quality Section**

**January 2014**

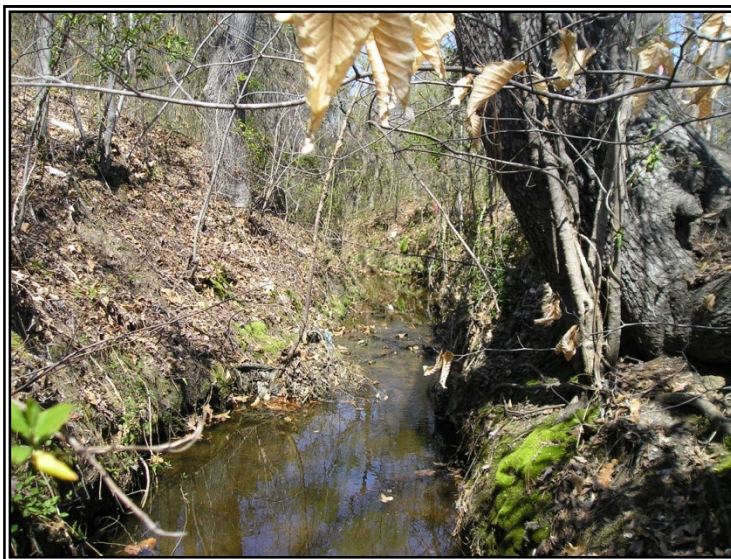
The habitat assessment score at this site was the lowest observed among all sites in 2013 and indicated a “Non-Supporting” condition for the reach. The streambed was comprised largely of cobbles with the epifaunal substrate metric returning a marginal value. Pool substrate was characterized by a mix of soft sand/sediment and the reach contained a preponderance of shallow pools. Sediment deposition was noticeable throughout the majority of the site’s length. The channel flow status was optimal. The reach exhibited historic channelization and as a result lacked strong sinuosity. Both stream banks exhibited obvious areas of scour/erosion down to bedrock in some areas and were sparsely vegetated. The riparian areas on either side were narrow with parking lots and university buildings present. An attempted buffer replanting was present along the right bank.

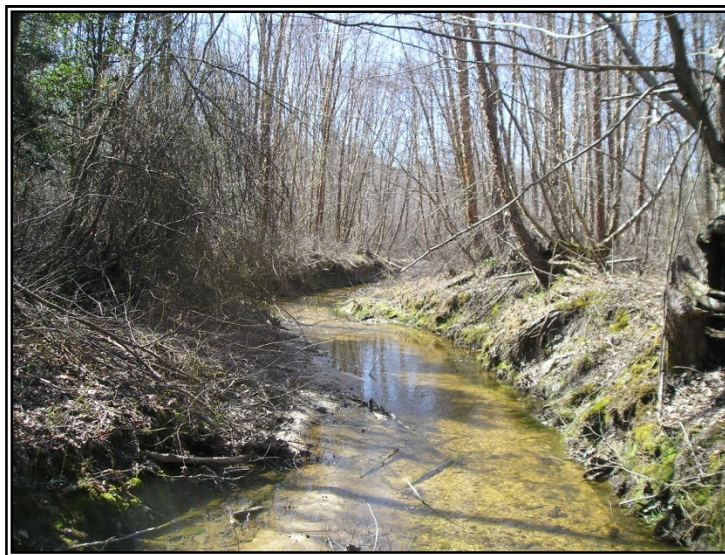
View is downstream

The habitat assessment in 2013 indicated a “Supporting” condition. The stream reach exhibited optimal substrate and instream habitat characteristics (e.g. non-embedded gravel/cobbles, snags and woody debris) for the maintenance of the benthic macroinvertebrate community. Pool substrate was comprised largely of firm sand/gravel and the majority of the pools within the reach were large and deep. A slight degree of sediment deposition was observed along portions of the site. The channel flow status was optimal with water reaching the base of both banks but sinuosity was marginal. The stream was in its natural state with no recent or apparent alterations. Both banks were stable and well vegetated with only sparse areas of erosion noted. Riparian areas were completely undisturbed.

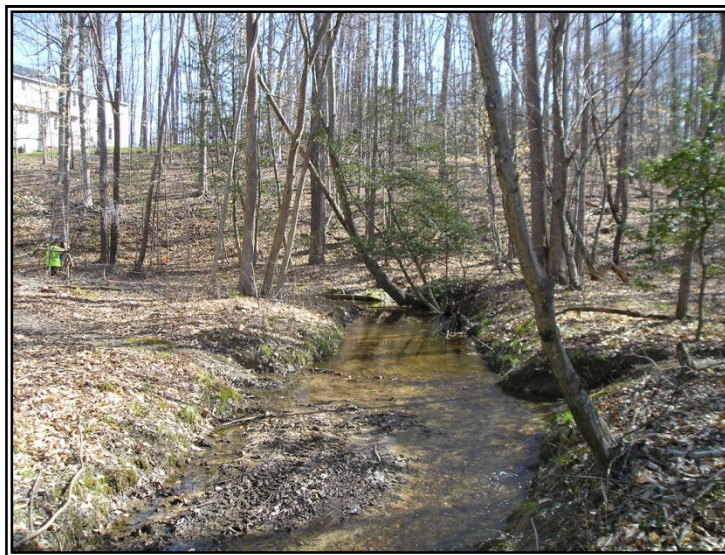
The habitat assessment in 2013 indicated a “Comparable to Reference” condition and was the highest assessment among all sites. The stream reach exhibited optimal substrate and instream habitat characteristics (e.g. non-embedded gravel/cobbles, snags and woody debris) for the maintenance of the benthic macroinvertebrate community. Pool substrate was comprised largely of firm sand/gravel and the majority of the pools within the reach were large and deep. A moderate degree of sediment deposition was observed throughout the site. The channel flow status was optimal with water reaching the base of both banks and sinuosity was excellent. The stream was in its natural state with no recent or apparent alterations. Both banks were stable and well vegetated with only occasional sparse areas of erosion noted. Riparian areas were undisturbed.

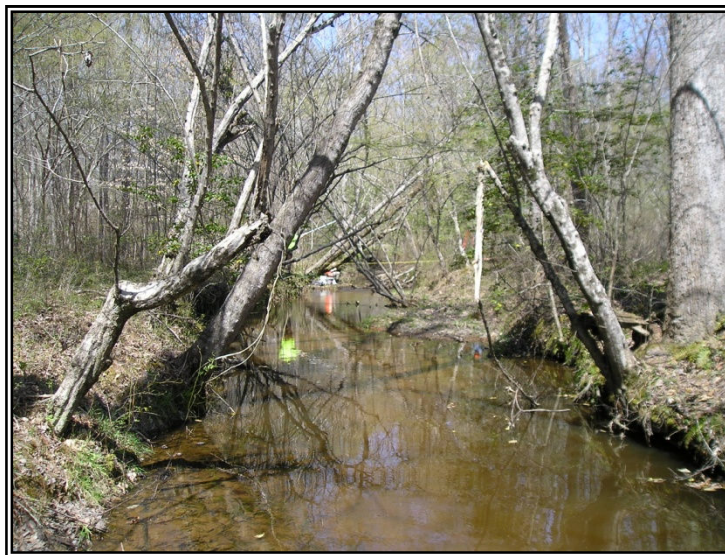
The habitat assessment in 2013 indicated a “Supporting” condition. With a few exceptions, the overall reach habitat characteristics were very similar to site APR-02. The stream reach exhibited excellent substrate and instream habitat characteristics (e.g. non-embedded gravel/cobbles, snags and woody debris) for the maintenance of the benthic macroinvertebrate community. Pool substrate was comprised largely of firm sand/gravel and the pools within the reach were a mixture of size and depth. A moderate degree of sediment deposition was observed throughout the site. The channel flow status was ideal with water reaching the base of both banks and sinuosity was marginal. The stream was in its natural state with no recent or apparent alterations. Both banks were stable and well vegetated with only sparse areas of erosion noted. Riparian areas were undisturbed. This reach’s riparian and bank structure scored highest among all sites.

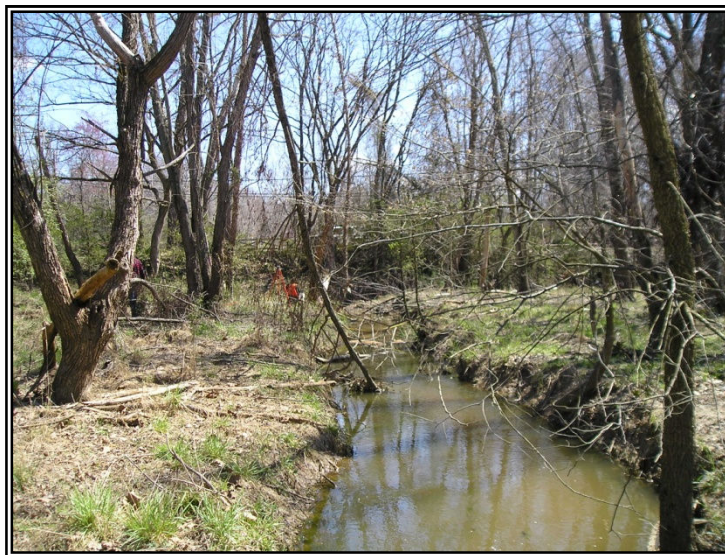
The habitat assessment score at this site was the second lowest observed among all sites in 2013 and indicated a “Non-Supporting” condition for the reach. The streambed was comprised largely of fine silt/sand with the epifaunal substrate metric returning a marginal value. Pool substrate was largely mud and the reach contained a preponderance of large deep pools. Fine sediment deposition was prevalent throughout the site’s length. The channel flow status was optimal. The reach appeared to show evidence of historic channelization and as a result lacked strong sinuosity. Both stream banks exhibited obvious areas of scour/erosion and were sparsely vegetated. The riparian areas on either side were a combination of old and active agricultural fields (hay).

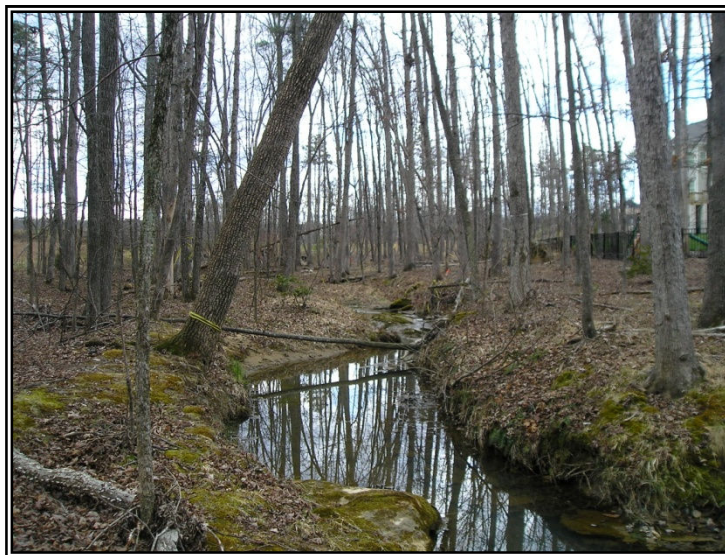
The habitat assessment in 2013 indicated a “Non-Supporting” condition. The stream reach exhibited suitable substrate and instream habitat characteristics for the maintenance of the benthic macroinvertebrate community with gravel, cobble and exposed bedrock/boulders present. Pool substrate was comprised largely of firm sand/gravel and pool variability was suboptimal. Observed sediment deposition was minimal throughout the site. The channel flow status was optimal with water reaching the base of both banks and sinuosity was excellent. The stream was in its natural state with no recent or apparent alterations aside from an upstream crossing. Both stream banks exhibited obvious areas of heavy scour/erosion and as a result were sparsely vegetated. A sanitary easement along the left bank and yards/homes along the right bank decreased the depth and quality of the riparian buffer areas.

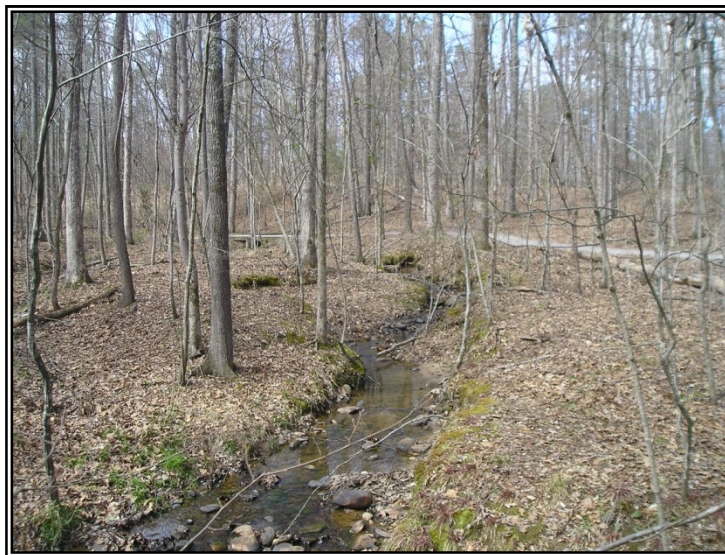
The habitat assessment in 2013 indicated a “Non-Supporting” condition. The stream reach exhibited suboptimal substrate and instream habitat characteristics (e.g. non-embedded gravel/cobbles, snags and woody debris) for the maintenance of the benthic macroinvertebrate community. Pool substrate was comprised largely of sand/gravel and the majority of the pools within the reach were shallow with some large and deep. Observed sediment deposition was visible throughout the site. The channel flow status was optimal and sinuosity was excellent. The stream was in its natural state with no recent or apparent alterations. Both stream banks exhibited obvious areas of heavy scour and erosion and as a result were sparsely vegetated. Riparian areas were largely undisturbed.

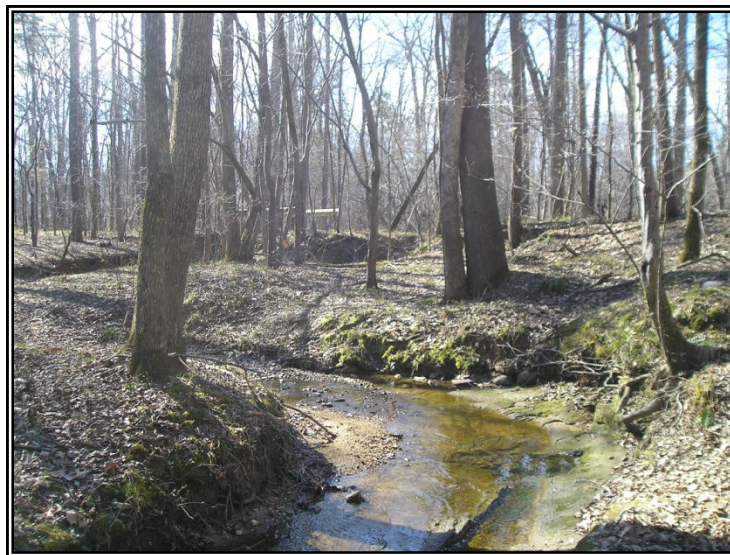
The habitat assessment in 2013 indicated a “Supporting” condition. The stream reach exhibited excellent substrate and instream habitat characteristics (e.g. non-embedded gravel/cobbles, snags and woody debris) for the maintenance of the benthic macroinvertebrate community. Pool substrate was comprised largely of mixed materials (firm sand/gravel/cobbles) and the majority of the pools within the reach were shallow. Observed sediment deposition was minimal throughout the site. The channel flow status was optimal with water reaching the base of both banks and sinuosity was generally lacking. The stream was in its natural state with no recent or apparent alterations. Both banks were stable and well vegetated with only sparse areas of erosion and scour noted. Riparian areas were undisturbed.

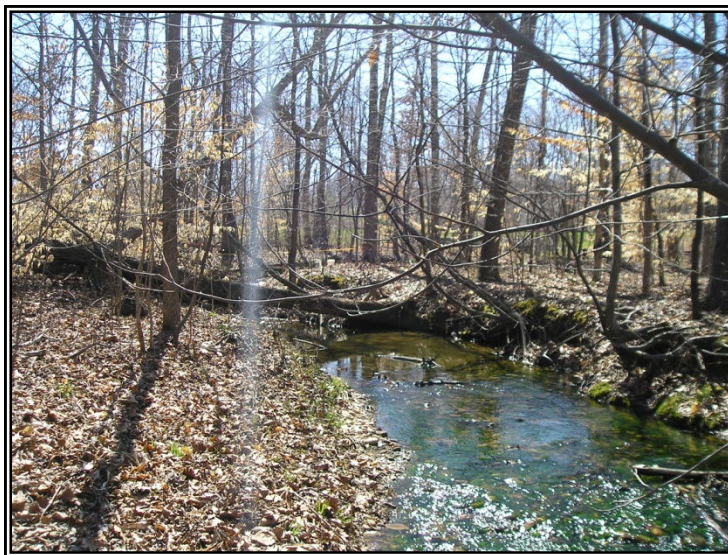
The habitat assessment in 2013 indicated a “Supporting” condition. The stream reach exhibited suitable substrate and instream habitat characteristics for the maintenance of the benthic macroinvertebrate community with firm sand, gravel and cobble present. Pool substrate was comprised largely of an optimal mixture of bed materials and the majority of the pools were large and deep. Observed sediment deposition was minimal throughout the site. The channel flow status was optimal with water reaching the base of both banks and sinuosity was excellent. The stream was in its natural state with no recent or apparent alterations aside from the upstream road crossing. Both stream banks exhibited obvious areas of heavy scour and erosion and as a result were sparsely vegetated. The riparian area depth along the right and left bank were decreased due to a residential development.

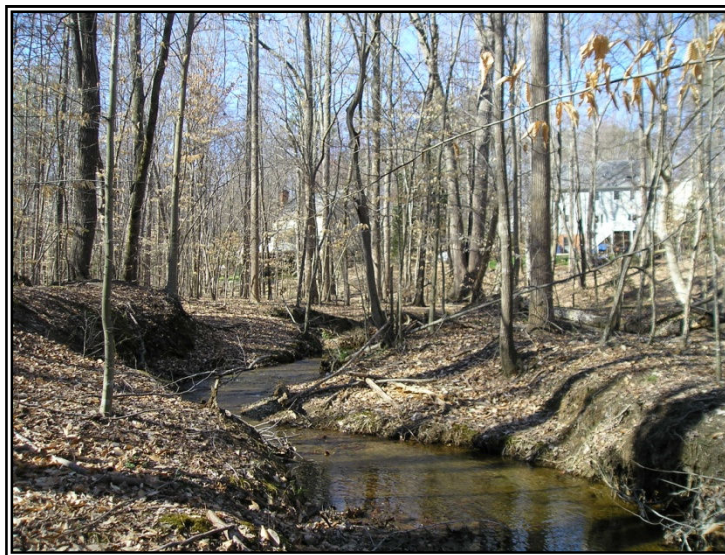
The habitat assessment in 2013 indicated a “Partially Supporting” condition. The stream reach exhibited optimal substrate and instream habitat characteristics for the maintenance of the benthic macroinvertebrate community with firm sand, gravel and cobble present. Pool substrate was comprised largely of a mixture of bed materials and pool variability was excellent with a mix of deep and shallow pools. Observed sediment deposition was minimal throughout the site. The channel flow status was optimal with water reaching the base of both banks and sinuosity was adequate. The stream was in its natural state with no recent or apparent alterations. Both stream banks exhibited obvious areas of scour and erosion and as a result were poorly vegetated. The riparian area along the right bank was in its natural condition and the depth along the left bank was decreased due to existing homes.

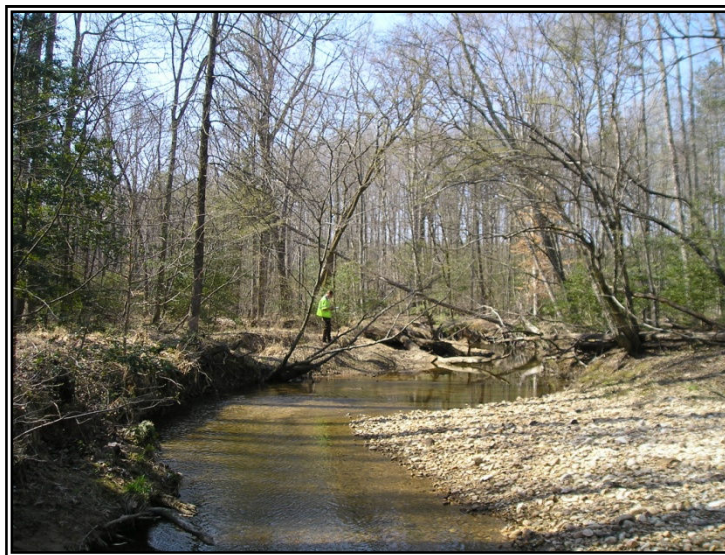
The habitat assessment in 2013 indicated a “Supporting” condition. The stream reach exhibited excellent substrate and instream habitat characteristics (e.g. non-embedded gravel/cobbles, snags and woody debris) for the maintenance of the benthic macroinvertebrate community. Pool substrate was comprised largely of an optimal mixture of bed materials and pool variability was excellent. There was a slight increase in sediment deposition throughout the site. The channel flow status was optimal with water reaching the base of both banks and sinuosity was excellent. The stream was in its natural state with no recent or apparent alterations. Both stream banks exhibited obvious areas of heavy scour/erosion but with most areas well vegetated. Riparian areas were completely undisturbed.

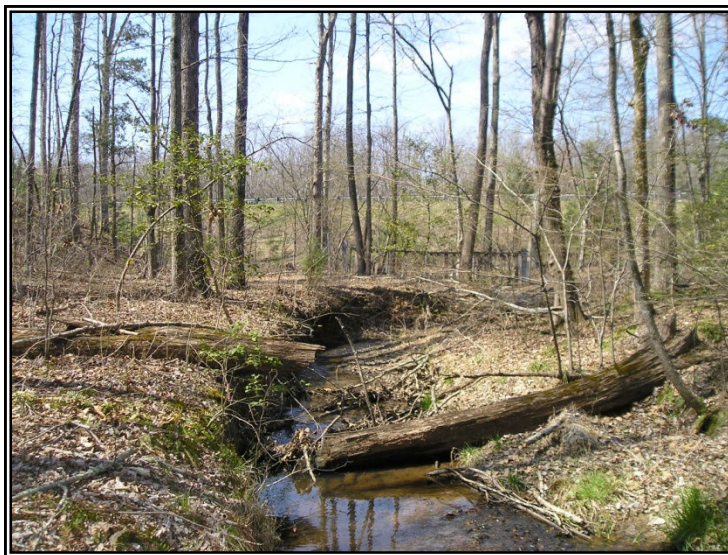
The habitat assessment in 2013 indicated a “Supporting” condition. The stream reach exhibited optimal substrate and instream habitat characteristics (e.g. non-embedded gravel/cobbles, snags and woody debris) for the maintenance of the benthic macroinvertebrate community. Pool substrate was comprised of a optimal mixture of sand and gravel and the majority of the pools within the reach were large and deep. A slight degree of sediment deposition was observed along portions of the site. The channel flow status was optimal with water reaching the base of both banks and sinuosity was excellent. The stream was in its natural state with no recent or apparent alterations. Both stream banks exhibited areas of erosion but with most areas well vegetated. Riparian areas were completely undisturbed.

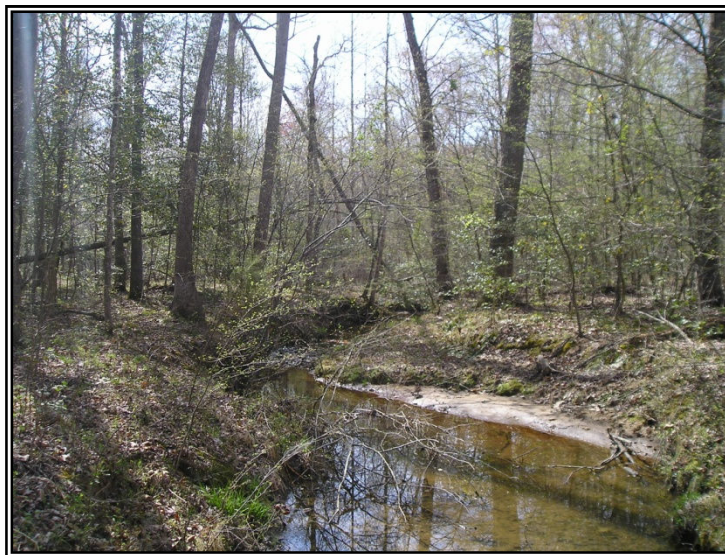
The habitat assessment in 2013 indicated a “Supporting” condition. With a few exceptions, the overall reach habitat characteristics were very similar to sites MCX-01 and MCX-02. The stream reach exhibited borderline optimal/suboptimal substrate and instream habitat characteristics (e.g. non-embedded gravel/cobbles, snags and woody debris) for the maintenance of the benthic macroinvertebrate community. Pool substrate was comprised largely of a suboptimal mixture sand/gravel and the majority of the pools within the reach were large and deep. There was minimal sediment deposition present throughout the site. The channel flow status was optimal with water reaching the base of both banks and sinuosity was excellent. The stream was in its natural state with no recent or apparent alteration. Both stream banks exhibited areas of erosion but with most areas well vegetated. Riparian areas were completely undisturbed.

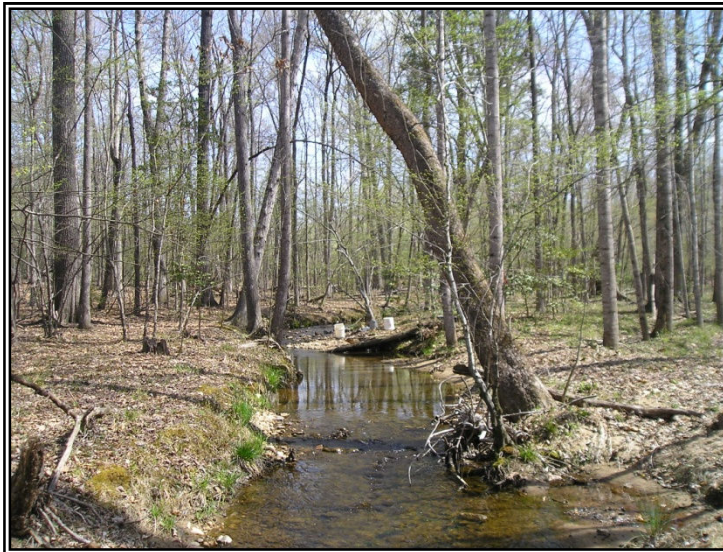
The habitat assessment in 2013 indicated a “Partially Supporting” condition. The stream reach exhibited suboptimal substrate and instream habitat characteristics for the maintenance of the benthic macroinvertebrate community with firm sand/gravel and cobble present along the length. Pool substrate was comprised largely of a suboptimal mixture of sand/gravel and the majority of the pools within the reach were large and deep. Observed sediment deposition was minimal throughout the site. The channel flow status was optimal with water reaching the base of both banks. The reach exhibited historic channelization and as a result lacked sinuosity. The stream was in its natural state with no recently apparent alterations aside from the upstream road crossing. Both stream banks exhibited areas of scour/erosion but with areas of partial vegetation. The riparian area depth along the right bank was decreased due to an existing sanitary sewer easement.

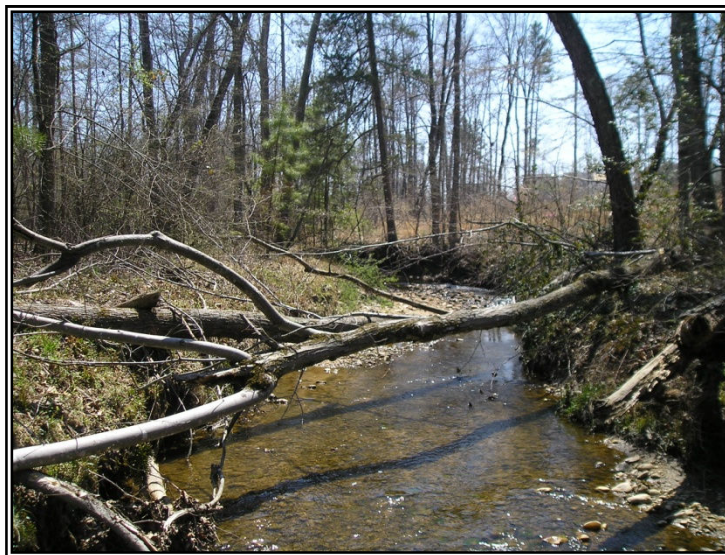
The habitat assessment in 2013 indicated a “Supporting” condition. The stream reach exhibited optimal substrate and instream habitat characteristics for the maintenance of the benthic macroinvertebrate community with firm sand/gravel and cobble present along the length. Pool substrate was comprised largely of a suboptimal mixture of sand/gravel and the majority of the pools within the reach were large and deep. Sediment deposition was minimal throughout the reach. The channel flow status was optimal with water reaching the base of both banks and sinuosity was adequate. The stream was in its natural state with no recently apparent alterations aside from an upstream road crossing. Both stream banks exhibited areas of scour/erosion but with most areas well vegetated. The riparian area depths along both banks were decreased due to the presence of a recent cutover along the left and the construction of a road along the right.

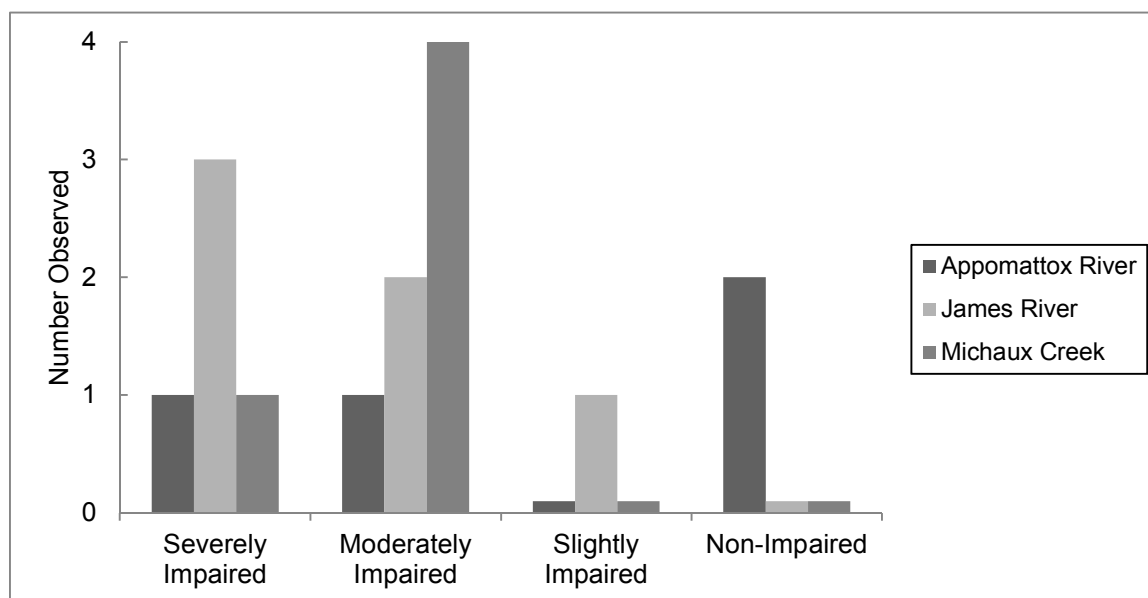
Figure 1. Categorical bioassessment observations in select watershed of Chesterfield County, 2013.

A summary of the bioassessment categories of the three monitored watersheds indicated that 80 percent of sites sampled (n=12) scored in the two lower categories during 2013 (Figure 1). Five sites were classified as “Severely Impaired” and seven were assessed as “Moderately Impaired.” One site in the James River watershed (JR-09) exhibited a “Slightly Impaired” bioassessment condition and two sites (APR-02 and APR-03) were assessed as “Non-Impaired” in 2013. The overall best bioassessment scores were noted in the Appomattox River watershed with the characterization of half of the sites as “Non-Impaired.”

Four sites were investigated at small stream systems draining directly to the Appomattox River with bioassessment observations in three of the four categories (Figure 1). The best bioassessment scores observed in 2013 were noted within this data set with two of the four reaches assessed returning values of a “Non-Impaired” status. At these two sites, total taxa and EPT taxa richness values were among the best observed in 2013 indicating a wide variety of organisms. For the second consecutive year, the Stoney Creek (APR-02; “Non-Impaired”), benthic macroinvertebrate community was not dominated by a single organism and was comprised largely of pollution sensitive taxa. At Tributary to Appomattox River (APR-03; “Non-Impaired”), an increase in pollution sensitive taxa and total taxa richness and a decrease in the percent dominant taxon resulted in a two category improvement from Moderately Impaired in 2012. Both Stoney Creek and Tributary to Appomattox River had moderate or excellent percentages of collector/gatherer, predator and scraper taxa indicating a well balanced and functional benthic community.

A summary of the bioassessment categories of the monitored watersheds indicated that 80 percent of sites sampled (n=12) scored in the two lower categories during 2013 (Figure 1). Five sites were classified as "Severely Impaired" and seven were assessed as "Moderately Impaired." One site in the James River watershed (JR-09) exhibited a "Slightly Impaired" bioassessment condition and two sites (APR-02 and APR-03) were assessed as "Non-Impaired" in 2013. The overall best bioassessment scores were noted in the Appomattox River watershed with the characterization of half of the sites as "Non-Impaired."

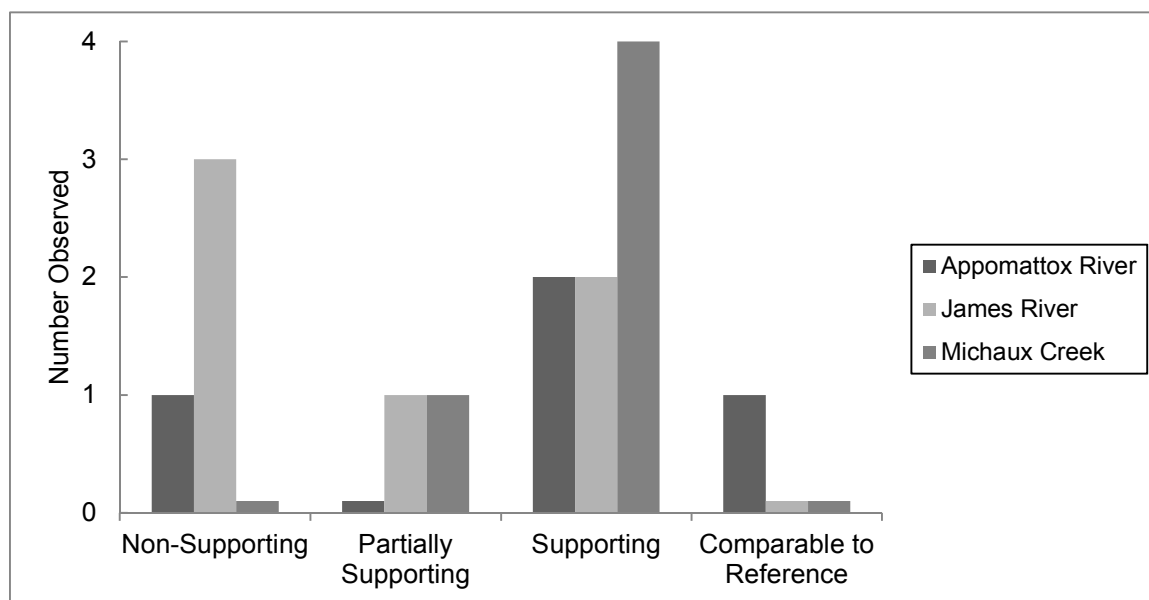
Figure 2. Categorical habitat assessments in select watersheds of Chesterfield County, 2013.

A summary of the habitat categories of each monitored watershed indicated that the majority of sites (eight) assessed scored as “Supporting” in 2013 (Figure 2). Two sites were assessed as “Partially Supporting” and four demonstrated a “Non-Supporting” condition. One reach investigated scored a value indicating a “Comparable to Reference” status.

During 2013, Tributary to the Appomattox (APR-03), in the Appomattox River drainage indicated a “Comparable to Reference” habitat condition (Figure 2) an improvement over the 2012 assessment of “Supporting.” The Stoney Creek (APR-02) and Cattle Creek (APR-04), assessments indicated a “Supporting” habitat condition. The score assessments of these three streams varied by nine points or less indicating that while they are categorically different, the habitats are characteristically similar. Each of these streams is located in relatively undeveloped forested areas with some impact from large lot residential housing. The substrate and instream habitat in the form of non-embedded gravel/cobbles, snags and woody debris was prevalent in each of these streams, allowing for full colonization by the benthic macroinvertebrate community. Pools lacked significant sedimentation and were generally large and deep. Sediment deposition varied from minimal to moderate and flow within the stream reaches was excellent. These three streams were in their natural state, exhibiting varying degrees of sinuosity with no visibly recent alterations save for upstream road crossings present. Stream banks appeared stable and were well vegetated. Riparian areas were fully forested and undisturbed. The remaining Appomattox drainage reach assessed in this data set was located along Fleets Branch (APR-01) and bisected the Virginia State University campus. The habitat assessment score at this site was the lowest observed in 2013 and indicated a “Non-Supporting” status. Instream substrate and habitat was marginal, consisting of cobbles and gravel, pools were relatively shallow and filled with soft sediment. The reach exhibited historic channelization and lacked sinuosity. The stream was deeply incised with frequent areas of erosion and scour readily visible. As a result, the banks were sparsely vegetated. Both riparian areas were comprised of parking lots and academic buildings and a buffer replanting project was attempted along the right bank. Additionally, the presence of floatables/trash was noted throughout the reach and most likely the result of improper disposal by pedestrians that use the two stream bridge crossings.

A summary of the habitat categories of each monitored watershed indicated that the majority of sites (eight) assessed scored as "Supporting" in 2013. Five sites were assessed as "Non-Supporting" and two demonstrated a "Partially Supporting" condition. One reach scored a value indicating a "Comparable to Reference" status.
